## **Historic Structure Assessment for Building 839, Carlisle Barracks**

Carlisle, Pennsylvania

October 2017

Final report

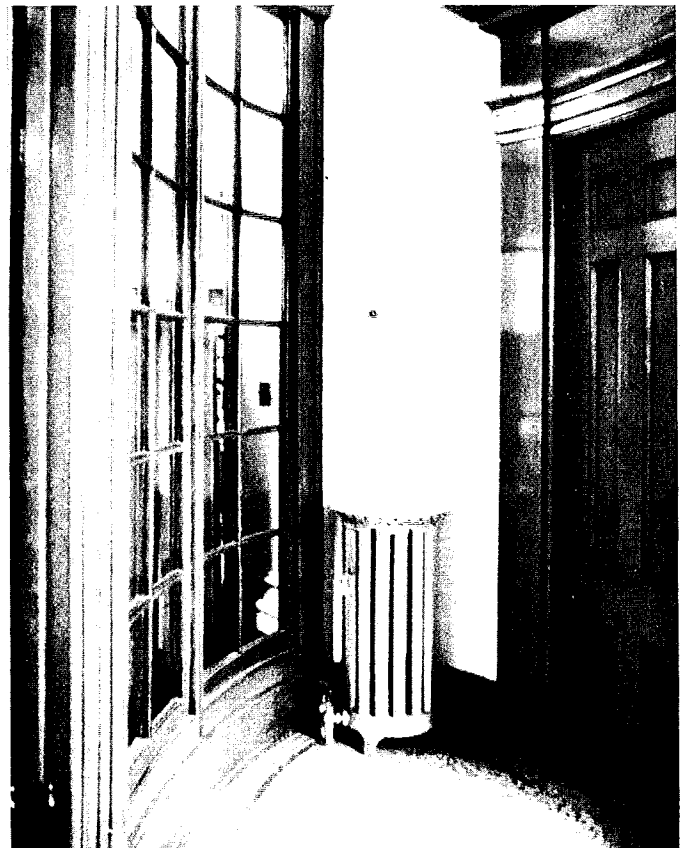
6. A condition assessment during the planning stage would identify this round radiator in a small oval-shaped vestibule as a significant element of the historic heating system. In upgrading the mechanical system, the radiator should be retained. Photo: Michael C. Henry, P.E., AIA.

3. **Undertake a condition assessment of the existing building and its systems.** What are the existing construction materials and mechanical systems? What condition are they in and are they reusable (see figure 6)? Where are existing chillers, boilers, air handlers, or cooling towers located? Look at the condition of all other services that may benefit from being integrated into a new system, such as electrical and fire suppression systems. Where can energy efficiency be improved to help downsize any new equipment added, and which of the historic features, e.g. shutters, awnings, skylights, can be reused (see figure 7)? Evaluate air infiltration through the exterior envelope; monitor the interior for temperature and humidity levels with hygrothermographs for at least a year. Identify building, site, or equipment deficiencies or the presence of asbestos that must be corrected prior to the installation or upgrading of mechanical systems.

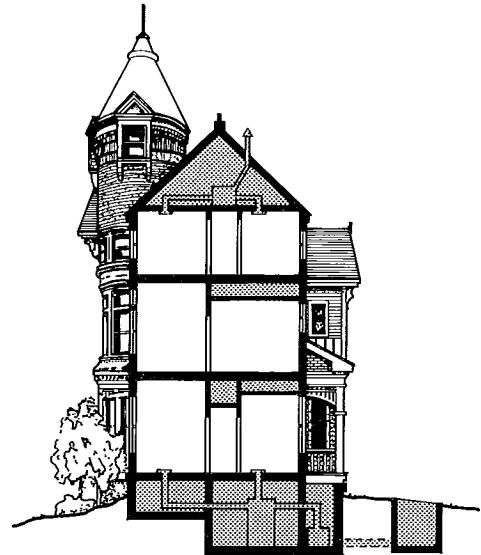
8. In considering options for new systems, existing spaces should be evaluated for their ability to house new equipment. This sketch shows several areas where new mechanical equipment could be located to avoid damaging significant spaces. Sketch: NPS files

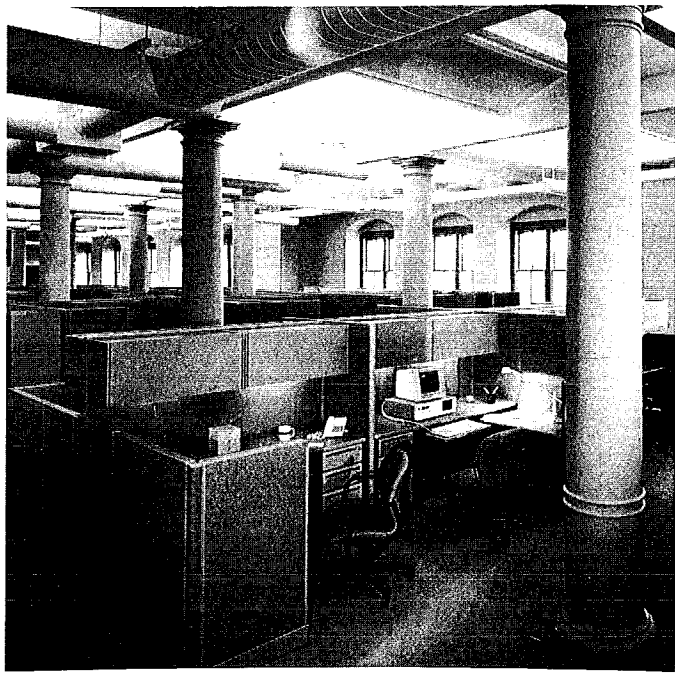
after

d. Auditors Buildings, Washington, D.C. This upper floor workspace had been modified over the years with dropped ceilings and partitions. In the recent restoration, the open plan workspace was restored, the false ceiling was removed, and the fireproof construction was exposed. A variable air volume (VAV) system using round double shell exposed ductwork is in keeping with the industrial character of the architectural space. Photo: Kenneth Wyner Photography, courtesy of Notter Finegold + Alexander Inc. Before view provided by Notter Finegold + Alexander/Mariani.

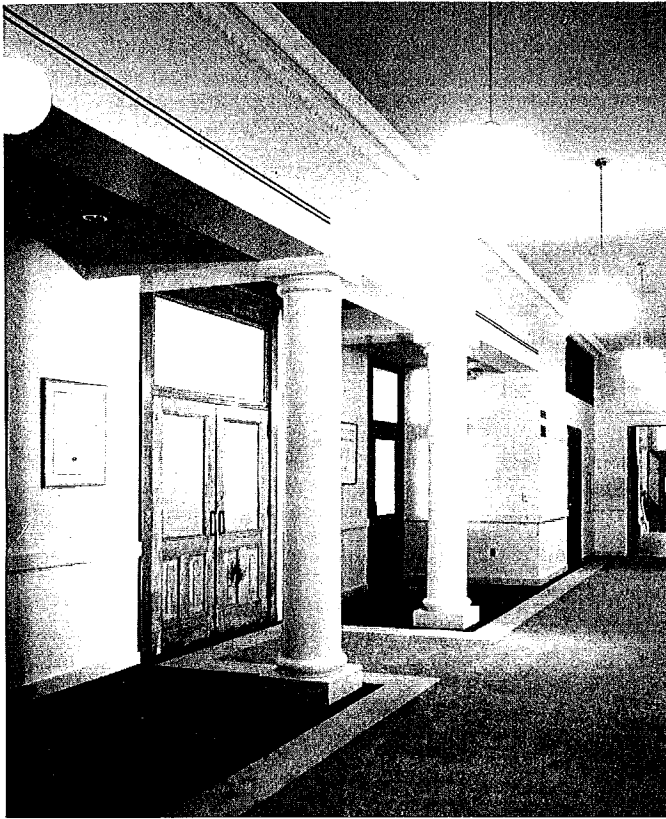
b. Central air conditioning was installed in the corridors of this circa 1900 school building by adding an air handler over the entrance from a vestibule. Custom-designed slot registers provide linear diffusers without detracting from the architecture of the space. Photo: Lautman Photography courtesy of Notter Finegold + Alexander Inc.

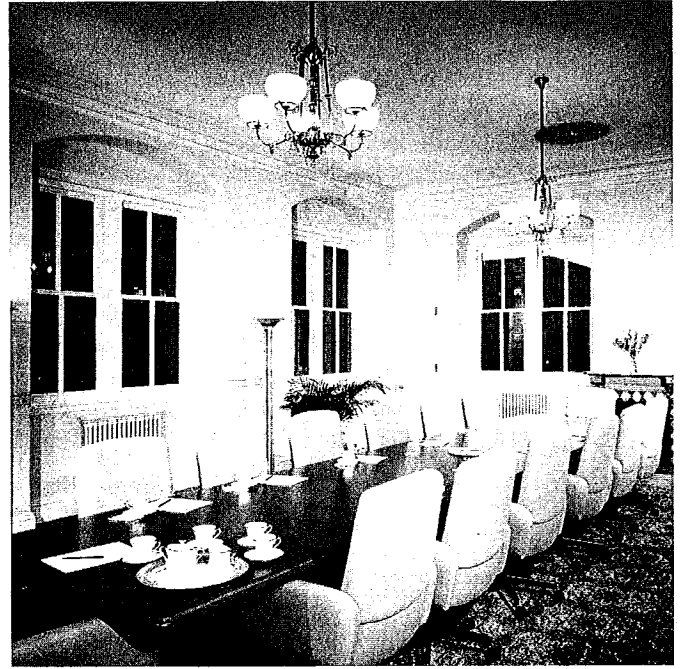
d. Conference room, Auditors Building, Washington, D.C. The historic steam radiators were retained for heating. The cast iron ceiling register was retained as a decorative element, but made inoperable to meet fire codes. Photo: Kenneth Wyner Photography courtesy of Notter Finegold + Alexander Inc.

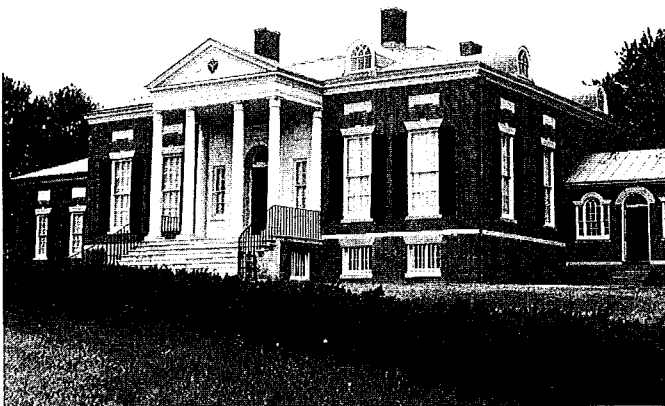
11. During the restoration of this 1806 National Historic Landmark (photo a), a new climate control system was installed. The architects removed all the earlier mechanical equipment from the house and installed new equipment in a 30' × 40' concrete vault located underground 150 feet from the house itself (photo b). Only conditioned air is blown into the house reusing much of the circa 1930s ductwork. Photos: Thomas C. Jester.

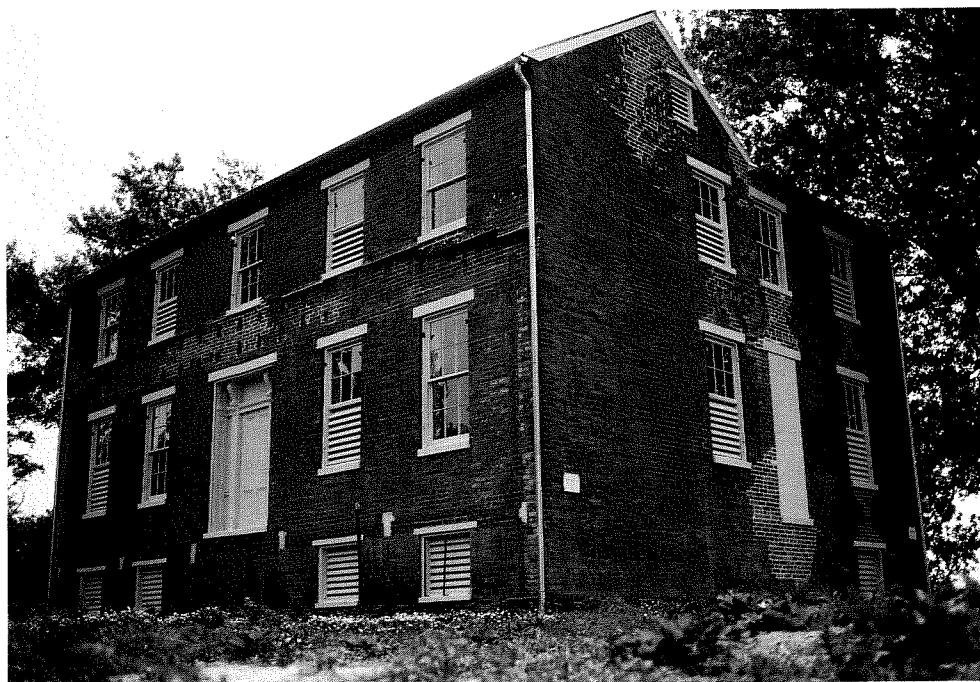
*Figure 1. Proper mothballing treatment: This building has been successfully mothballed for 10 years because the roof and walls were repaired and structurally stabilized, ventilation louvers were added, and the property is maintained. Photo: Charles E. Fisher, NPS.*

the door, setting heat levels at just above freezing, and securing the windows may provide sufficient protection for a period of a few years. But if long-term mothballing is the only remaining option, it must be done properly (see fig. 1 & 2). This will require stabilization of the exterior, properly designed security protection, generally some form of interior ventilation - either through mechanical or natural air exchange systems - and continued maintenance and surveillance monitoring.

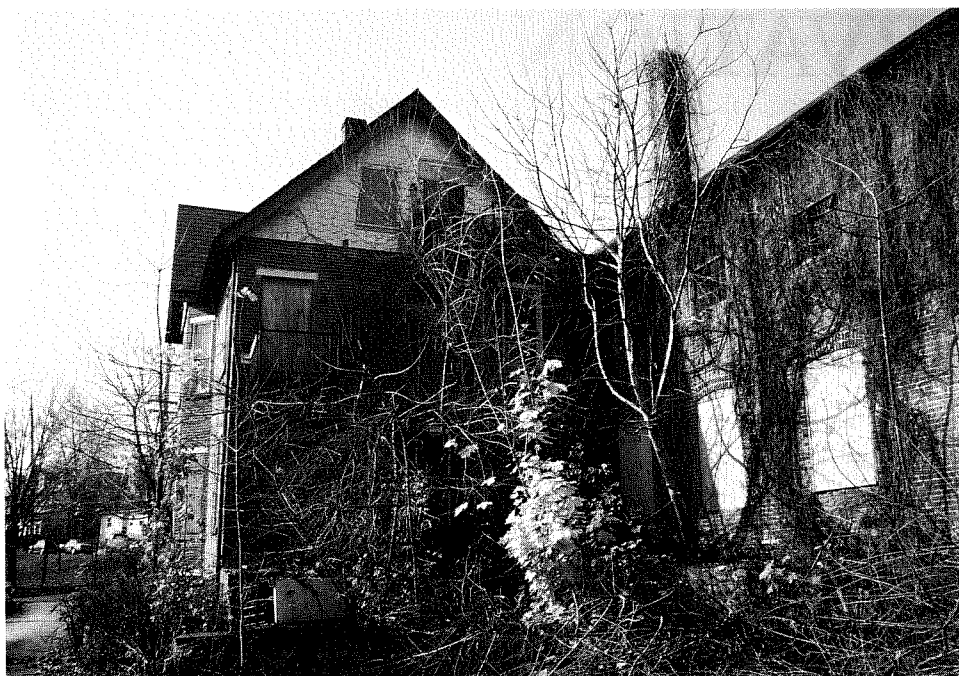
Figure 2. Improper treatment: Boarding up without adequate ventilation, lack of maintenance, and neglect of this property have accelerated deterioration. Photo; NPS file.

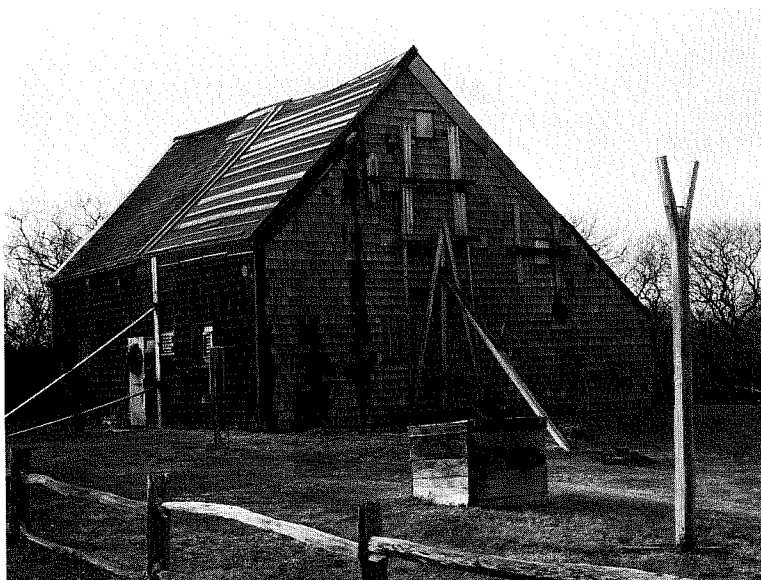
Figure 3. Buildings seriously damaged by storms or deterioration may need to be braced before architectural evaluations can be made. Jethro Coffin House. Photo: John Milner Architects.

to be structurally unsound until the condition of the structure can be fully assessed (see fig. 3). If pigeon or bat droppings, friable asbestos or other health hazards are present, precautions must be taken to wear the appropriate safety equipment when first inspecting the building. Consideration should be given to hiring a firm specializing in hazardous waste removal if these highly toxic elements are found in the building.

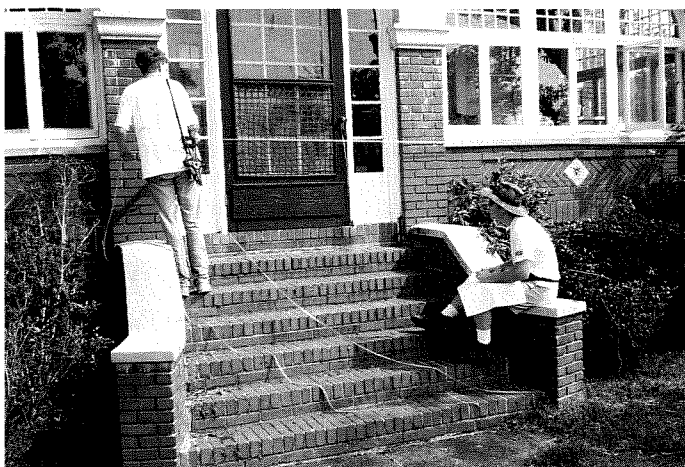
*Figure 4. Documenting the building's history, preparing schematic plans, and assessing the condition of the building will provide necessary information on which to set priorities for stabilization and repair prior to securing the building. Photo: Frederick Lindstrom, HABS.*

Old photographs can be helpful in identifying early or original features that might be hidden under modern materials. On a walk-through, the architect, historian, or preservation specialist should identify the architecturally significant elements of the building, both inside and out (see fig.4).

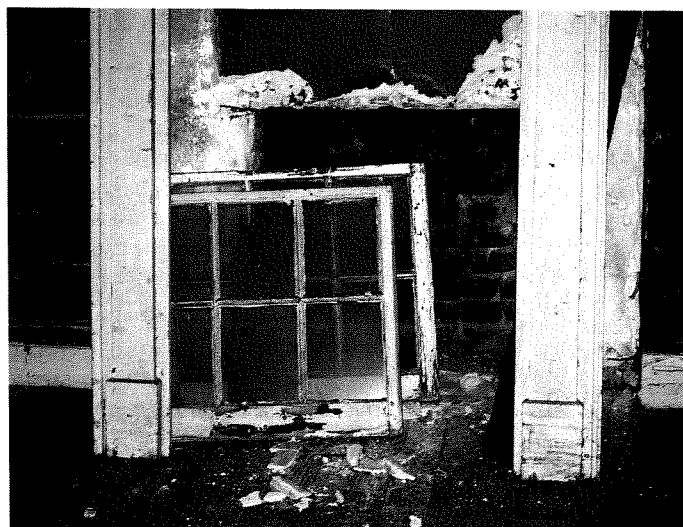
*Figure 5. Loose or detached elements should be identified, tagged and stored, preferably on site. Photo: NPS files.*

By understanding the history of the resource, significant elements, even though deteriorated, may be spared the trash pile. For that reason alone, any materials removed from the building or site as part of the stabilization effort should be carefully scrutinized and, if appearing historic, should be photographed, tagged with a number, inventoried, and safely stored, preferably in the building, for later retrieval (see fig. 5).

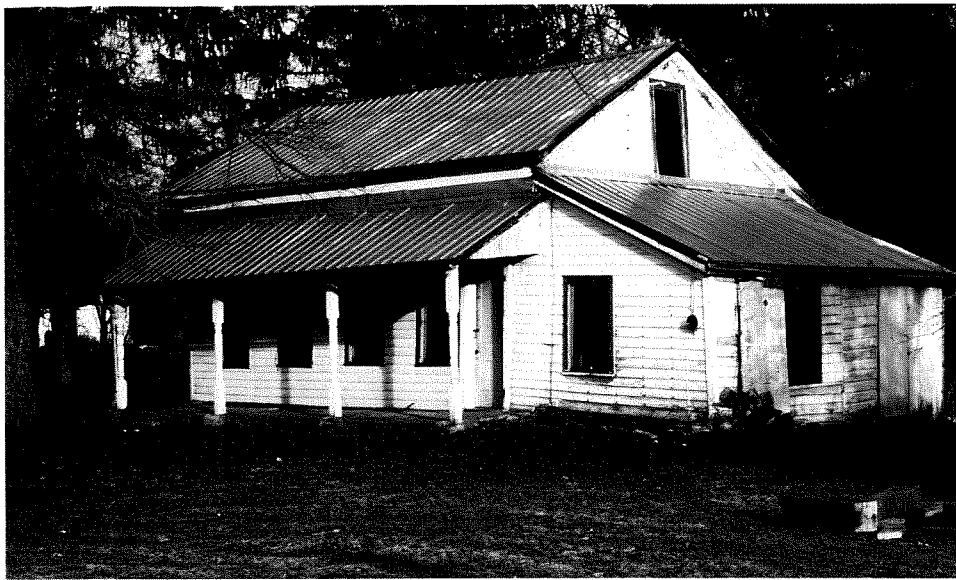
*Figure 7. Non-historic materials are appropriate for mothballing projects when they are used to protect historic evidence remaining for future preservation. This lightweight aluminum channel frame and roofing covers the historic wooden shingle roof. Galvanized mesh panels secure the window openings from intrusion by raccoons and other unwanted guests. Photo: Williamsport Preservation Training Center, NPS.*

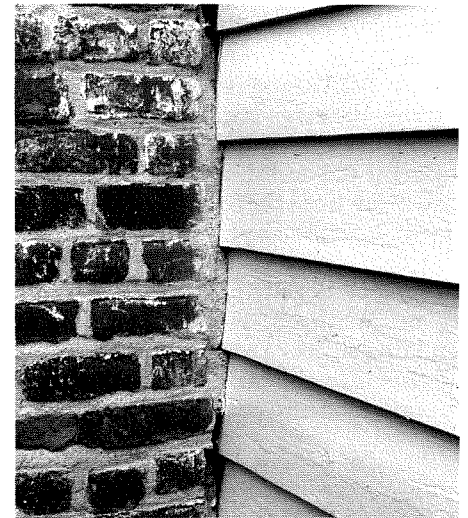
*Figure 8. Appropriate mortar mixes should be used when masonry repairs are undertaken. In this case, a soft lime based mortar is used as an infill between the brick and wooden elements. When full repairs are made during the restoration phase, this soft mortar can easily be removed and missing bricks replaced.*

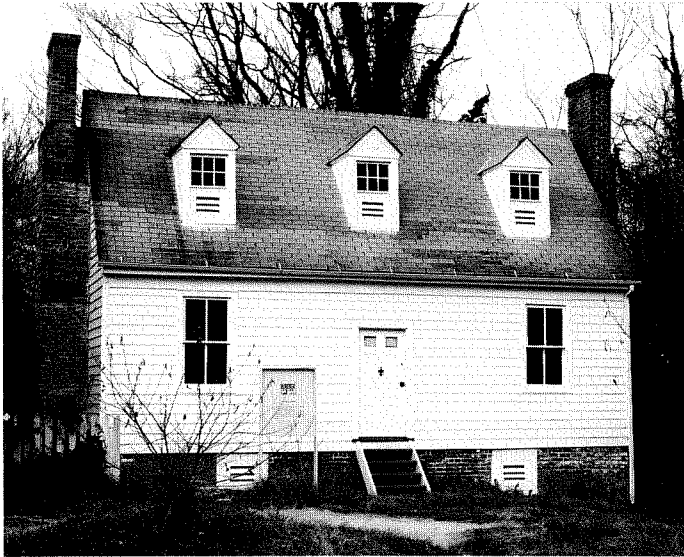
Figure 10. Regrading around the Booker Tenement at Colonial Williamsburg has protected the masonry foundation wall from excessive damp. This building has been successfully mothballed for over 10 years. Note the attic and basement vents, the temporary stairs, and the informative sign interpreting the history of this building.

If there are no significant landscape or exposed archeological elements around the foundation, consideration should be given to regrading the site if there is a documented drainage problem (see fig. 10). If building up the grade, use a fiber mesh membrane to separate the new soil from the old and slope the new soil 6 to 8 feet (200 cm-266 cm) away from the foundation making sure not to cover up the dampcourse layer or come into contact with skirting boards. To keep vegetation under control, put down a layer of 6 mil black polyethylene sheeting or fiber mesh matting covered with a 2"-4" (5-10 cm.) of washed gravel. If the building suffers a serious rising damp problem, it may be advisable to eliminate the plastic sheeting to avoid trapping ground moisture against foundations.

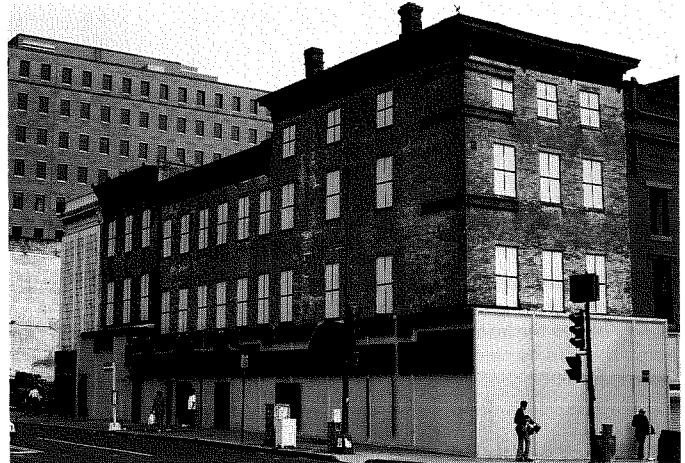
Figure 11. Urban buildings often need additional protection from unwanted entry and graffiti. This commercial building uses painted plywood panels to cover expansive glass storefronts and chain link fencing is applied on top of the panels. The upper windows on the street sides have been covered and painted to resemble 19th century sash. Photo: Thomas Jester, NPS.

Mothballed buildings are usually boarded up, particularly on the first floor and basement, to protect fragile glass windows from breaking and to reinforce entry points (see fig. 11). Infill materials for closing door and window openings include plywood, corrugated panels, metal grates, chain fencing, metal grills, and cinder or cement blocks (see fig. 12). The method of installation should not result in the destruction of the opening and all associated sash, doors, and frames should be protected or stored for future reuse.

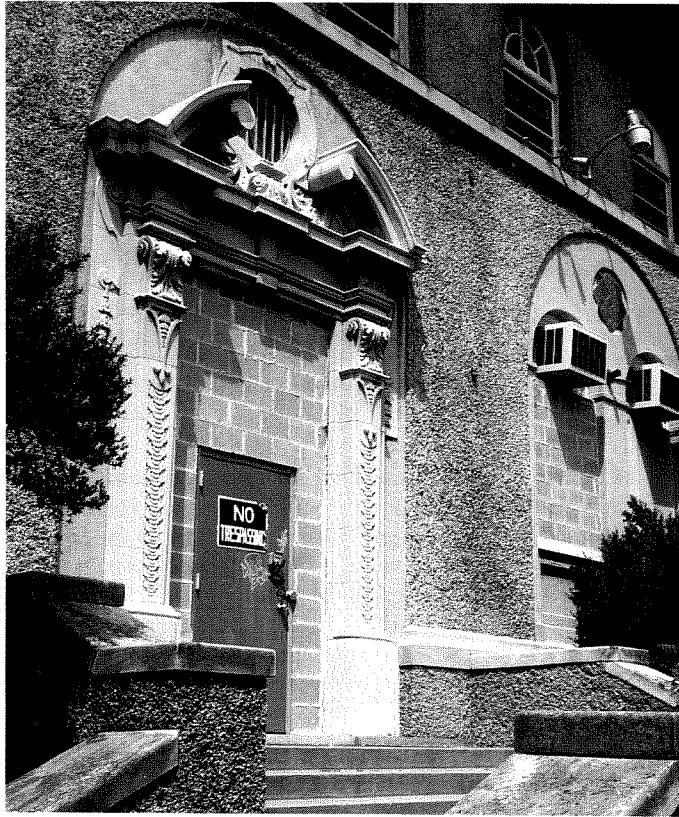
Figure 12. First floor openings have been filled with cinderblocks and doors, window sash and frames have been removed for safe keeping. Note the security light over the windows and the use of a security metal door with heavy duty locks. Photo: H. Ward Jandl, NPS.

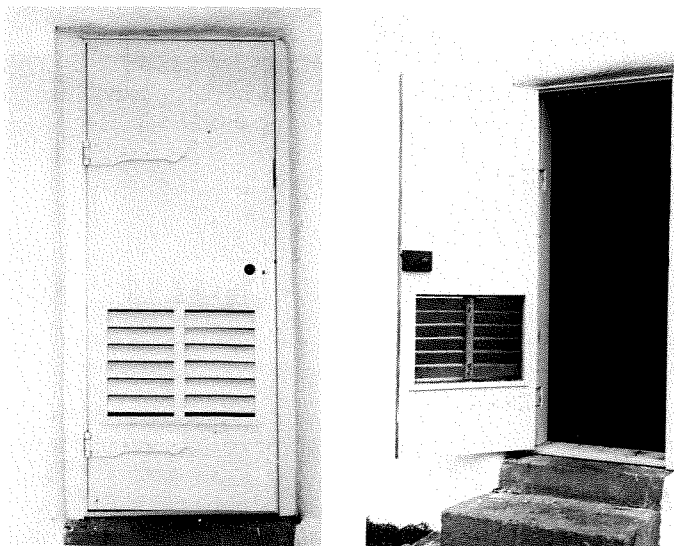
Figure 13. If historic doors would be damaged by adding extra locks, they should be removed and stored and new security doors added. At this lighthouse, the historic door has been replaced with a new door (seen both inside and outside) with an inset vent and new deadbolt locks. The heavy historic hinges have not been damaged. Photo: Williamsport Preservation Training Center, NPS.

Generally exterior doors are reinforced and provided with strong locks, but if weak historic doors would be damaged or disfigured by adding reinforcement or new locks, they may be removed temporarily and replaced with secure modern doors (see fig. 13). Alternatively, security gates in a new metal frame can be installed within existing door openings, much like a storm door, leaving the historic door in place. If plywood panels are installed over door openings, they should be screwed in place, as opposed to nailed, to avoid crowbar damage each time the panel is removed. This also reduces pounding vibrations from hammers and eliminates new nail holes each time the panel is replaced.

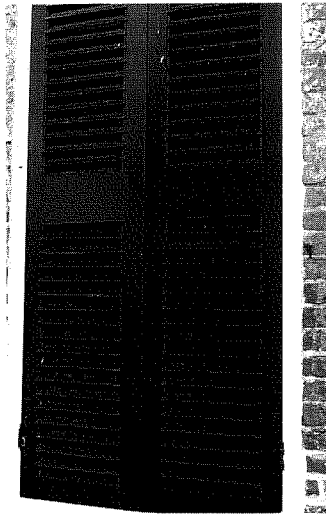
Figure 16. Historic louvered shutters make excellent security closures with passive ventilation.

If the building has shutters, simply close the shutters and secure them from the interior (see fig. 16). If the building had shutters historically, but they are missing, it may be appropriate to install new shutters, even in a modern material, and secure them in the closed position. Louvered shutters will help with interior ventilation if the sash are propped open behind the shutters.

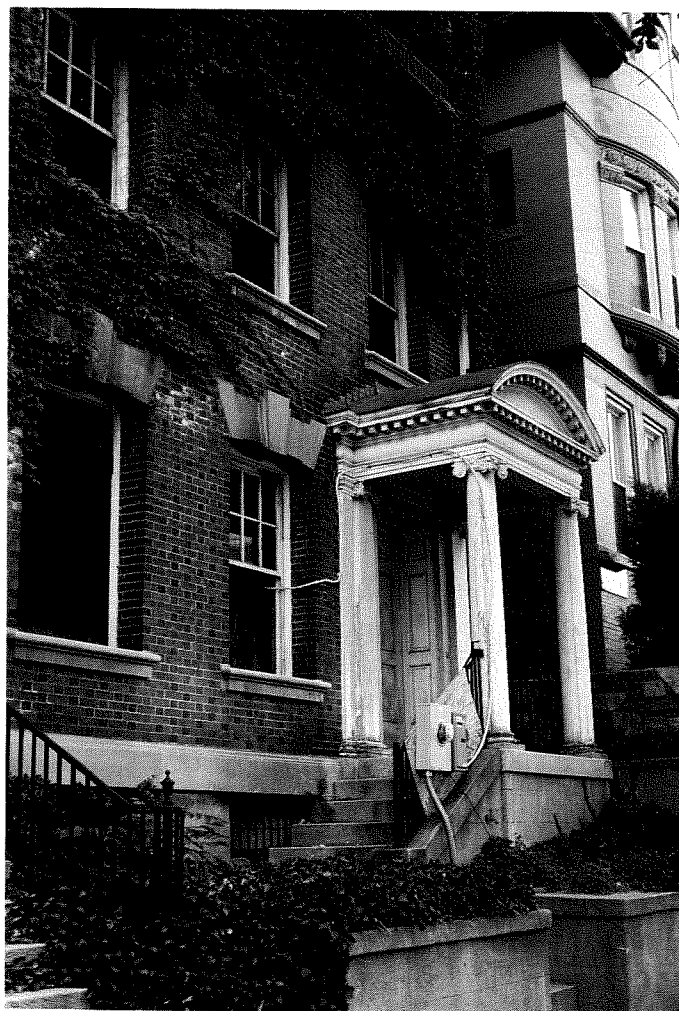
Figure 22. All systems except temporary electric have been shut off at this residence which has been mothballed over 20 years. An electric meter and 100 amp panel box have been set on a plywood panel at the front of the building. It is used for interior lighting and various alarm systems. The building, however, is showing signs of moisture problems with efflorescent stains on the masonry indicating the need for gutter maintenance and additional ventilation for the interior. The vegetation on the walls, although picturesque, traps moisture and is damaging to the masonry. Photo: H. Ward Jandl, NPS.

hazard, it is advisable to retain those which will help protect the property. Since the electrical needs will be limited in a vacant building, it is best to install a new temporary electric line and panel (100 amp) so that all the wiring is new and exposed. This will be much safer for the building, and allows easy access for reading the meter (see fig. 22).

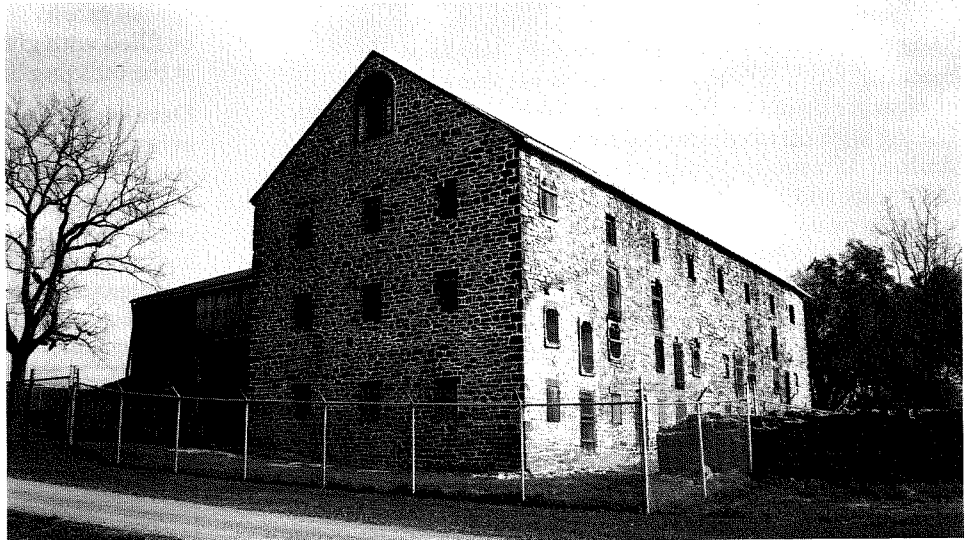
Figure 24. Once mothballed, a property must still be monitored and maintained. The openings in this historic barn has been modified with a combination of wood louvers and metal mesh panels which require little maintenance. The grounds are regularly mowed, even inside the chain link security fence. Photo: Williamsport Preservation Training Center, NPS.

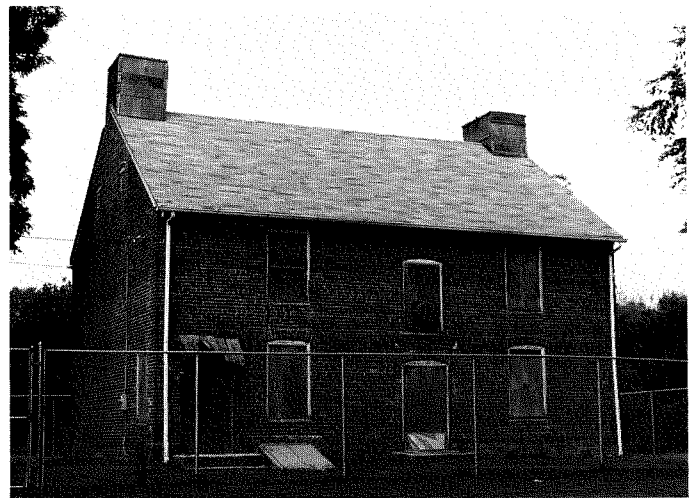
Figure 25. Above is a summary of the tasks that were necessary in order to protect this significant property while restoration funds are raised. Photographs: Michael Mills; Ford Farewell Mills Gatsch Architects.

a. A view showing the exterior of the house in its mothballed condition.

**Mothball:** Install security fence around the property. Secure doors and windows with plywood panels (½" exterior grade). Install preformed metal grills in basement and attic openings. Add surface mounted wiring for ionization smoke and fire detection with direct wire to police and fire departments. Shut off heat and drain pipes. Add window exhaust fan set on a thermostatic control. Provide for periodic monitoring and maintenance of the property.

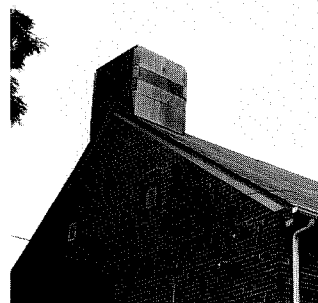
b. Plywood panels stabilize the chimneys. Note the gable vents.

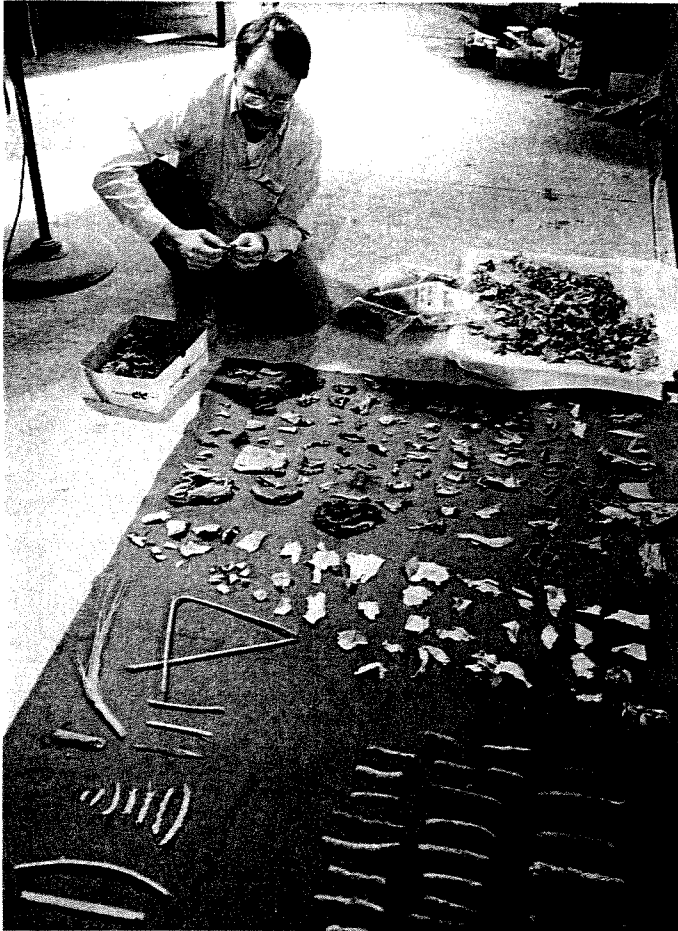
Figure 4. An inventory of animal nests found within hidden spaces of a structure may yield unexpected evidence, such as information about food, decorative arts, and cultural or social traditions of every day life. Typical items of paper, fabric and wood are important artifacts which are generally not found during archeology digs in the ground. photo: Tom Graves, Jr., courtesy Jefferson's Poplar Forest.

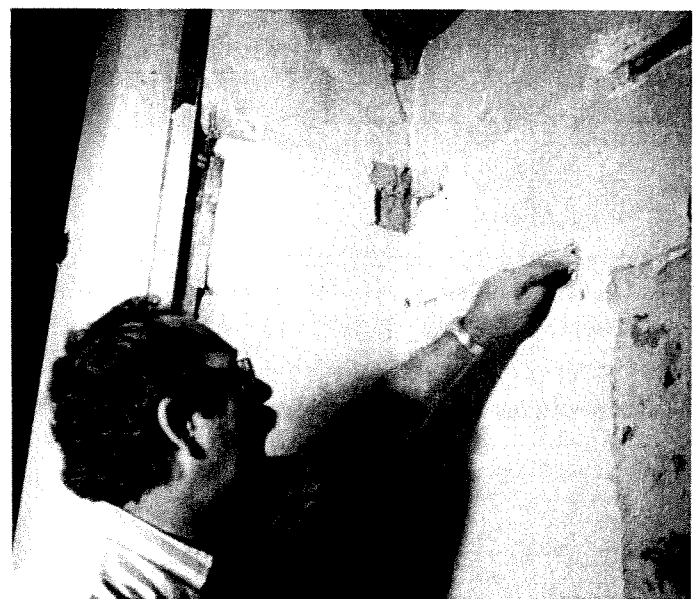
Figure 6. An investigator must have the skill and ability to closely observe and analyze the materials with a broad understanding of historic construction practices and technologies. Through the collection of samples and analysis of materials, investigative questions are either answered, refined, or formulated.

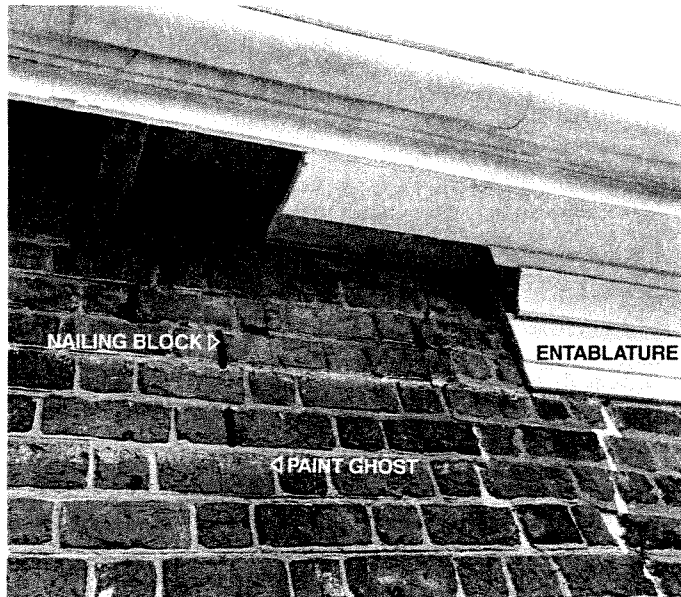
*Figure A. Careful examination of the masonry reveals different periods of construction and repair through the composition and detailing of bricks and mortar. Depending upon location, open vertical joints may indicate the location of nailing blocks for decorative trim or weeps for drainage. These open joints at the building's cornice show evidence of an earlier wooden entablature extending down two courses below the present trim. The paint ghosts below the lowest blocks confirms the entablature's existence and provides clues to its size and finish.*

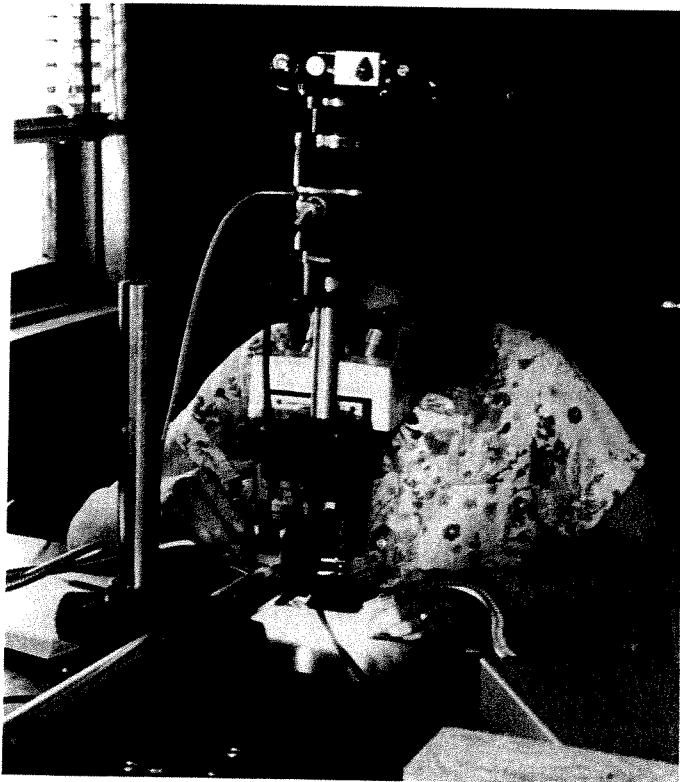
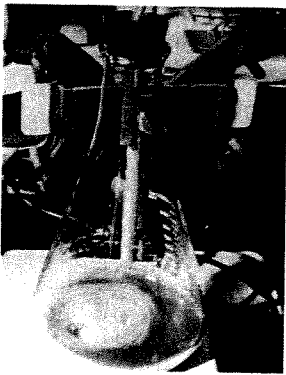
Figure 12. During a thorough investigation, the mortar sample is viewed under a microscope using various lighting to find the presence of coatings or additives. It is then ground and washed in an acid bath to separate and free the sand and fibers. After further cleaning, these fines are stored and used for comparison in matching or dating repairs and alterations. photos: NPS North Atlantic Cultural Resource Center, Building Conservation Branch.

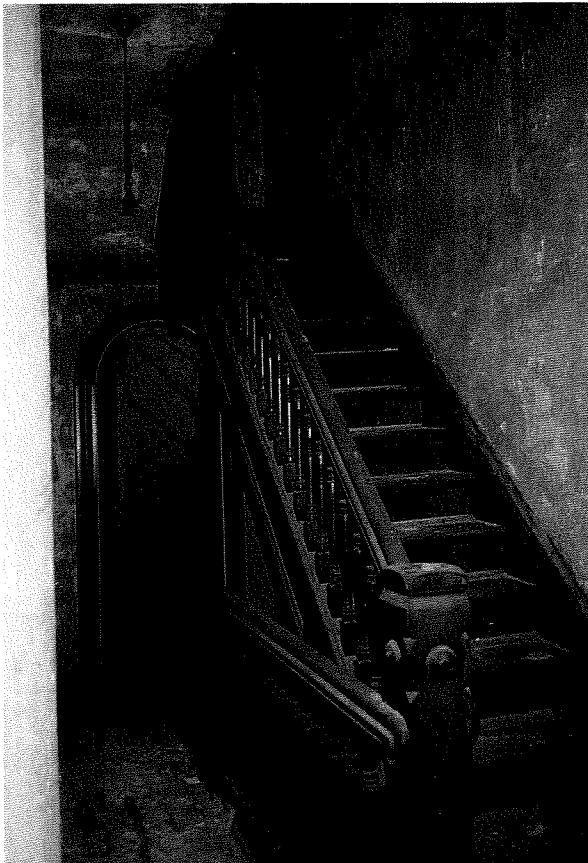
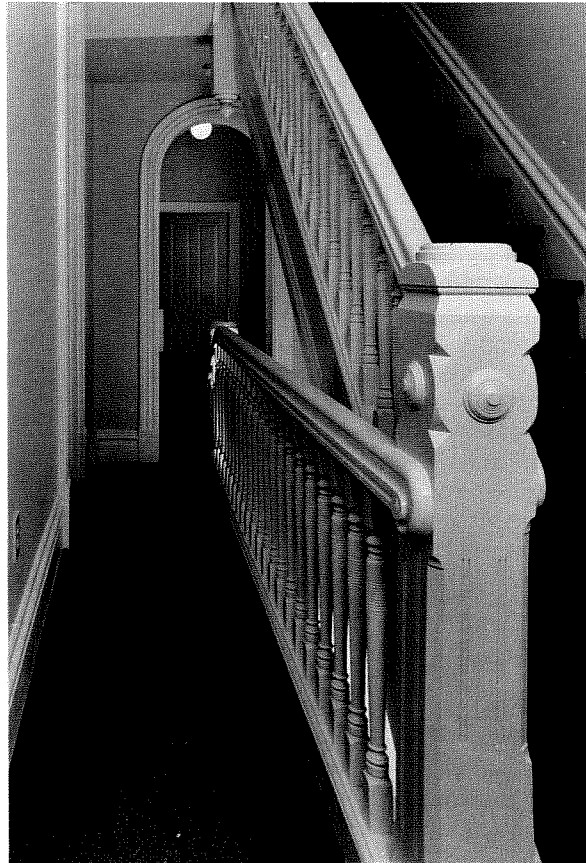
Figure 1. A large-scale historic rehabilitation project incorporated sensitive lead-hazard reduction measures. Interior walls and woodwork were cleaned, repaired, and repainted and compatible new floor coverings added. The total project was economically sound and undertaken in a careful manner that preserved the building's historic character. Photos: Landmarks Design Associates.

The premise of this Preservation Brief is that historic housing can be made lead-safe for children without removing significant decorative features and finishes, or architectural trimwork that may contribute to the building's historic character (see fig. 1). *Historic housing*—encompassing private dwellings and all types of rental units—is necessarily the focus of this Brief because federal and state laws primarily address the hazards of lead and

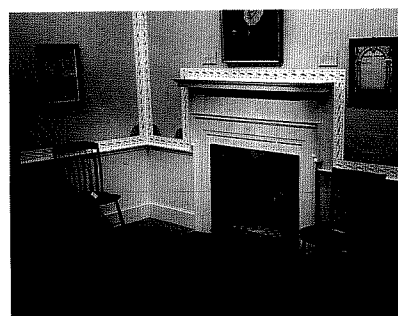
*Figure 3. Significant architectural features and their finishes should not be removed during a project incorporating lead hazard controls. If the decorative stenciling above, or hand grained doors below, or painted murals need repair, then a paint conservator should be consulted. Once loose paint is consolidated or otherwise stabilized, a clear finish or other reversible clear protective surface or coating can be added to areas subject to impact or abrasion. Photos: NPS Files.*

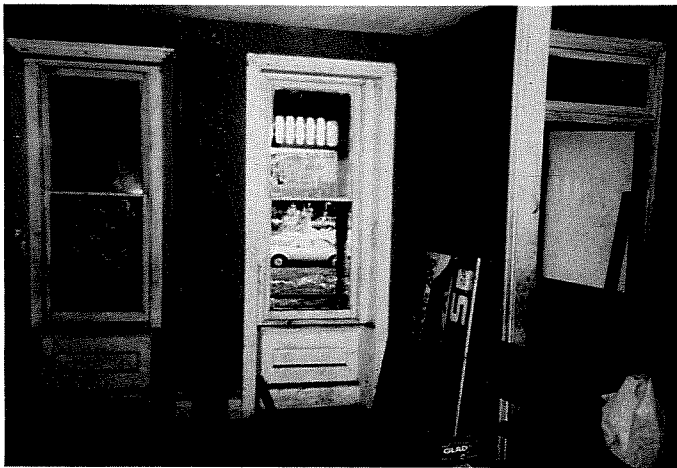
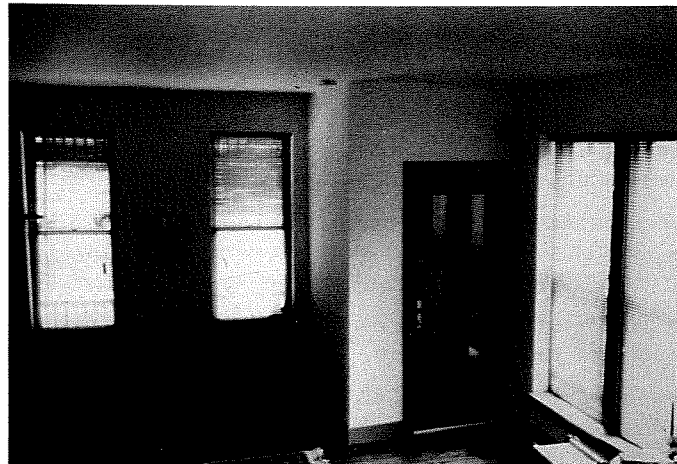
Figure 4. The typical method for abating lead-based paint through substrate removal is not consistent with the Standards for Rehabilitation. In this project, all the historic trim, base panels, and the transom were removed. While the unit is lead-safe, its character has been severely altered. Figure 5 shows a similar, but successful, balance of historic preservation and lead hazard control work. Photo: NPS Files.

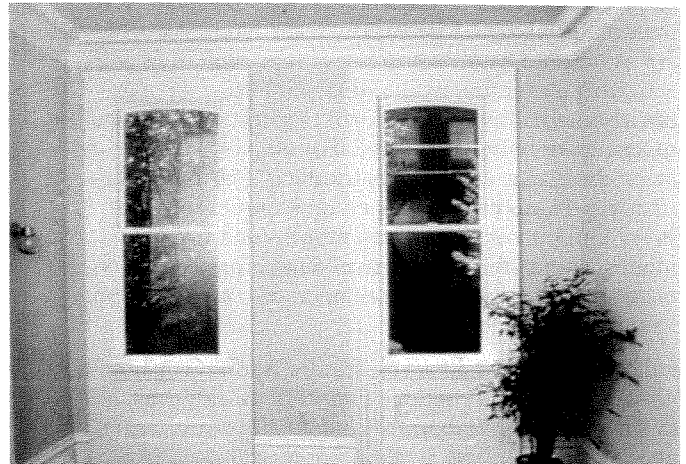
Figure 5. When historic interiors are rehabilitated, it is possible to remove the offending substance, such as deteriorated paint, without removing the features. In this case, the walls were repaired, and the trim and base panels were stripped of paint to a sound substrate, then repainted. Photos: Landmarks Design Associates.

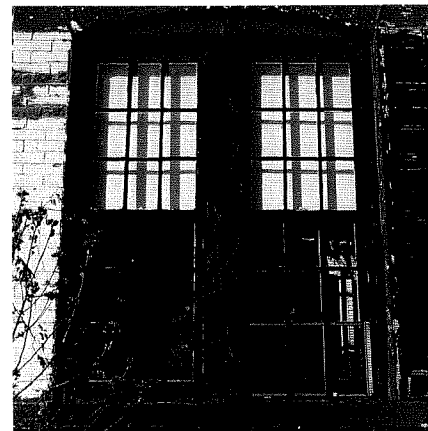
*Figure 7. Chalking exterior paint can cause dangerous lead levels in soil around a house. Lead levels are usually highest in the one foot wide area adjacent to the building foundation. In these cases, the existing soil should be replaced with new soil or sod. This is particularly important if children and small pets play in contaminated areas, then inadvertently track the dirt inside.*

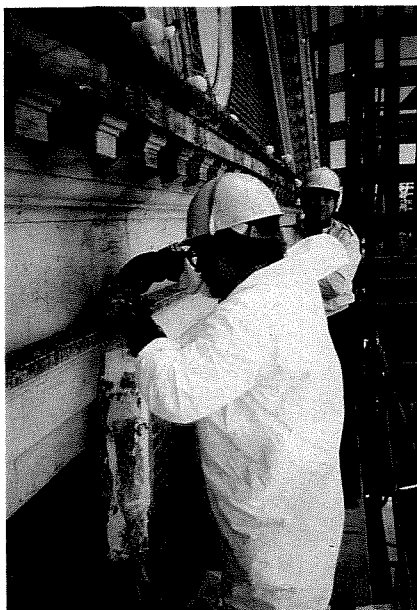
Figure 10. The choice of paint removal method will trigger various environmental controls and worker protection. The chemical poultice-type paint remover uses a paper backing that keeps the lead waste contained for proper disposal. The worker is adequately protected by a suit and gloves; for this work a respirator was not required. Local laws required containment and neutralization of any after-wash water run off. Photo: NPS Files.

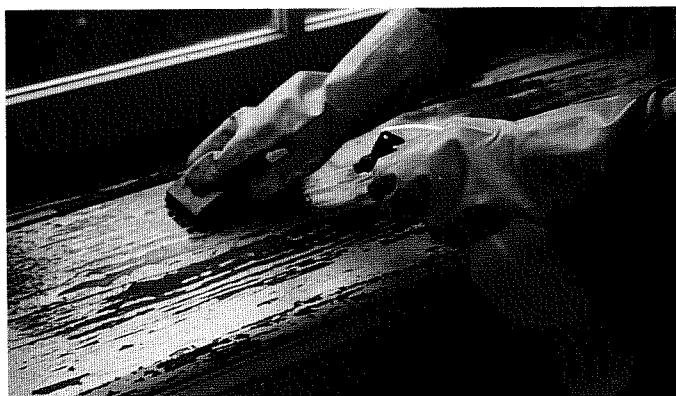
Figure 15. Wet sanding of interior surfaces will keep dust levels down, reduce the need for workers' protection, and provide a sound surface for repainting. Priming and repainting with oil/alkyd, latex or latex acrylic should be undertaken according to manufacturers' instructions.

If an owner undertakes interim controls, it would be advisable to receive specialized training in handling lead-based paint. Such training emphasizes isolating the area, putting plastic sheeting down to catch debris, turning off mechanical systems, taping registers closed, and taking precautions to clean up prior to handling food. Work clothes should be washed separately from regular family laundry. The preferred method for removing flaking paint is the wet sanding of surfaces because it is gentle to the substrate and controls lead dust. The key to reducing lead hazards while stabilizing flaking paint is to keep the surfaces slightly damp to avoid ingesting lead dust. Wet sanding uses special flexible sanding blocks or papers that can be rinsed in water or used along with a bottle mister. This method will generally not create enough debris to constitute hazardous waste (see fig. 15).

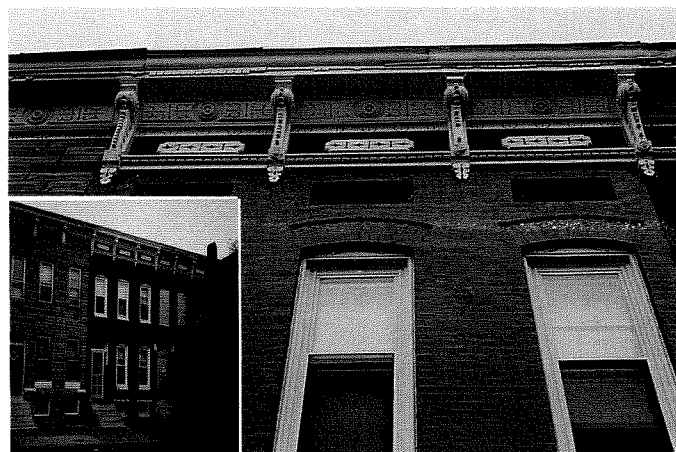
*Figure 18. As part of an urban housing grant program, the exterior of this row house was successfully made lead-safe and met the Secretary of the Interior's Standards for Rehabilitation. The exterior was washed, then repainted with exterior grade alkyd paint. The decorative roof brackets and cornice were repainted; not removed or covered as is often recommended in typical abatement guidelines. The previously altered, deteriorated window sash were replaced with new sash and jamb liners set within the historic frames. Photos: Deborah Birch.*

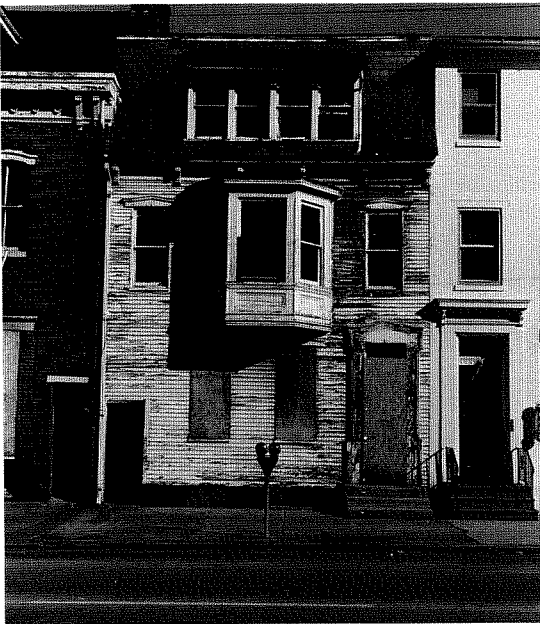
**Before**

*Figure 19. In many cases, exterior wood siding can be repaired, selectively replaced, and repainted, as illustrated in this successful residential rehabilitation. Deteriorating wood siding was removed from the foundation to the top of the first floor windows and replaced with matching wood siding. The entire building was repainted. Photos: Crispus Attucks Community Development Corporation.*

these materials on some historic frame buildings. If the repair or replacement of historic cladding on a primary elevation is being undertaken, such replacement materials should match the historic cladding in material, size, configuration, and detail (see fig. 19). The use of an artificial siding or aluminum coil stock panning systems over wooden trimwork or sills and lintels (as recommended in some abatement guidelines) is not appropriate, particularly on principal facades of historic buildings because they change the profile appearance of the exterior trimwork and may damage historic materials and detailing during installation. Unless the siding is too deteriorated to warrant repair and the cost is too prohibitive to use matching replacement materials (i.e., wood for wood), substitute materials are not recommended.

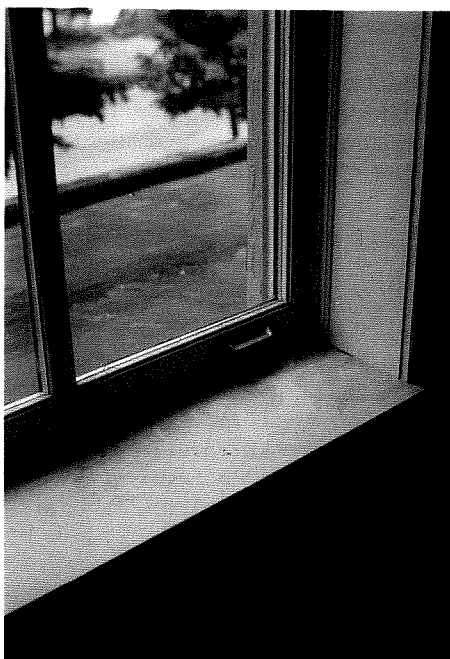
Figure 22. Research has shown that some small children will chew on projecting window sills while teething. As part of a lead hazard control project, the edge of the sill can be stripped to bare wood or an encapsulating paint applied. In this case, a new window sill was installed as part of a window upgrade that retained the historic trim and frame.

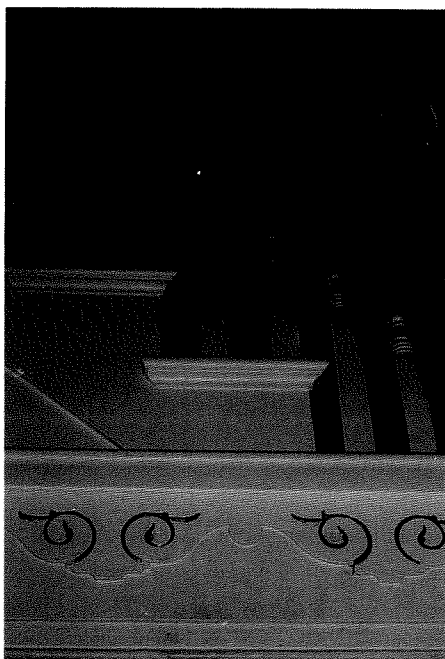
Figure 23. Stair banisters and railings are considered mouthable surfaces. In this case, the old paint was wet sanded to a sound layer. Special encapsulant paints were then applied in three thin layers to avoid obscuring the woodwork's fine detailing. It should be noted that many encapsulant paints are now treated with a bitter agent to discourage mouth contact. Photo: Landmarks Design Associates.

**Accessible, projecting, mouthable surfaces.** Accessible, chewable surfaces that can be mouthed by small children need not be removed entirely, as some health guidelines recommend. These accessible surfaces are listed as projecting surfaces within a child's reach, including window sills, banister railings, chair rails, and door edges. In many cases, the projecting edges can have all paint removed using wet sanding, a heat gun or chemical strippers, prior to repainting the feature (see fig. 22). If the homeowner feels that there is no evidence of unsupervised mouthing of surfaces, a regular paint may be adequate once painted surfaces have been stabilized. An encapsulant paint that adhesively bonds existing paint layers onto the substrate extends durability. While encapsulant paint systems are difficult to remove from a surface in the future, they permit retention of the historic feature itself. If encapsulant paint is used on molded or decorative woodwork, it should be applied in several thin coats to prevent the architectural detail from being obscured by the heavy paint (see fig 23).

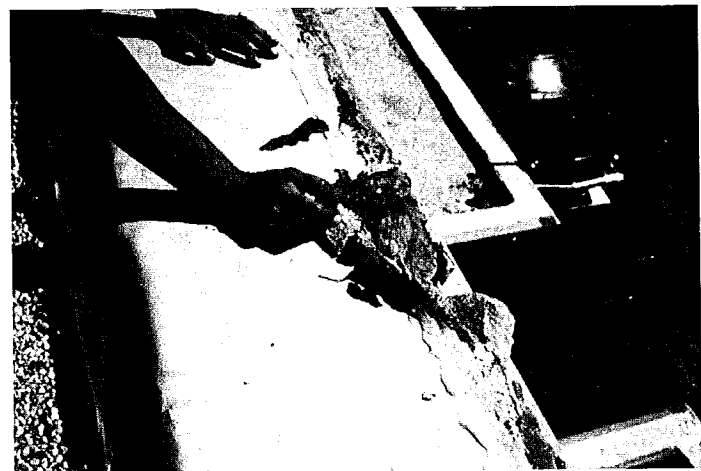
Fig. 1. Moisture problems, if not properly corrected, will increase damage to historic buildings. This waterproof coating trapped moisture from the leaking roof, causing portions of the masonry parapet to fail. Photo: NPS Files.

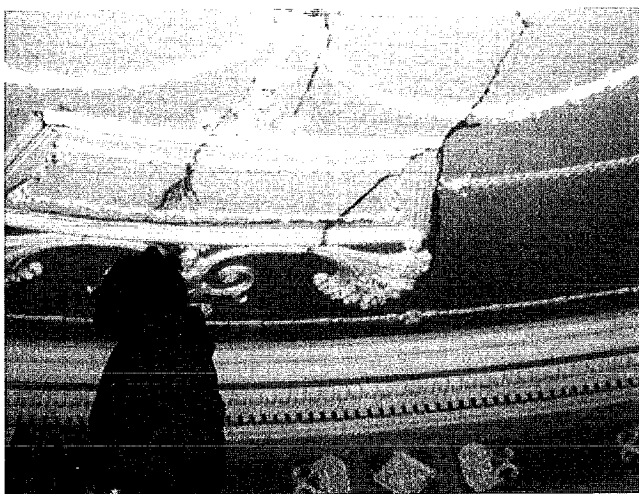
Fig. 6. Uninsulated plumbing pipes close to the exterior wall froze and cracked, wetting this ornamental plaster ceiling before the water supply line could be shut off. As a result, limited portions of the ceiling needed reattaching. Photo: author.

**Leaking plumbing pipes and mechanical equipment** can cause immediate or long-term damage to historic building interiors. Routine maintenance, repair, or, if necessary, replacement of older plumbing and mechanical equipment are common solutions. Older water and sewer pipes are subject to corrosion over time. Slow leaks at plumbing joints hidden within walls and ceilings can ultimately rot floor boards, stain ceiling plaster, and lead to decay of structural members. Frozen pipes that crack can damage interior finishes (see fig. 6 ). In addition to leaking plumbing pipes, old radiators in some historic buildings have been replaced with water-supplied fan coil units which tend to leak. These heating and cooling units, as well as central air equipment, have overflow and condensation pans that require cyclical maintenance to avoid mold and mildew growth and corrosion blockage of drainage channels. Uninsulated forced-air sheet metal ductwork and cold water pipes in walls and ceilings often allow condensation to form on the cold metal, which then drips and causes bubbling plaster and peeling paint. Careful design and vigilant maintenance, as well as repair and insulating pipes or ductwork, will generally rid the building of these common sources of moisture.
